# "Mold Gets 10 Years to Life"

The following case study involves a prominent upper Midwest maximum security prison, which was built in 1982. The architect who designed the building won an award for innovative techniques in reducing energy consumption. In reducing energy consumption however, he ended up creating an environment conducive to mold growth on the interior surfaces of the duct work.

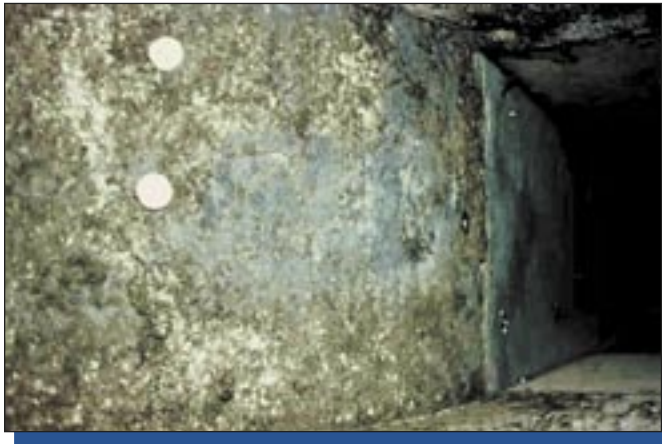
Prior to application of Foster® 40-20™ coating, fungal wipe samples on the fibrous glass duct liner showed average fungal levels of 45,000 colony forming units per square centimeter (cfu/cm2).

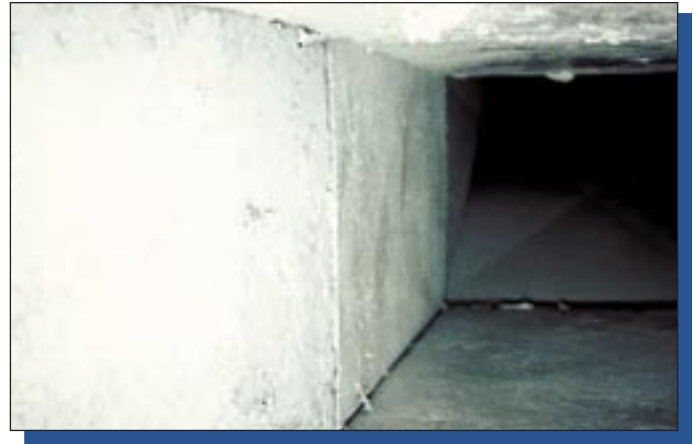
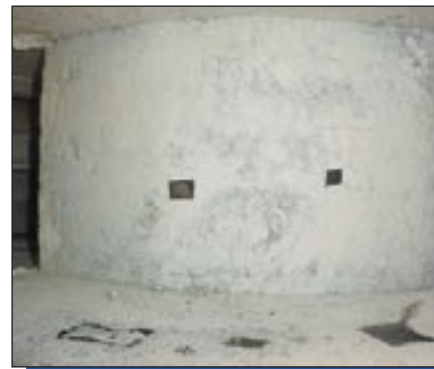
After ten years the fungal wipe samples from the coating surface areas showed an average of 7 cfu/cm2 -meaning nominal growth!

After vacuuming the duct liner, Foster 40-20 coating was applied by airless sprayer in accordance with the manufacturer's specifications to designated areas, at the direction of Mr. Ellringer.
